PROJECT REPRESENTATIVE'S DAILY REPORT

Pg. 1
Report No. 052
Date: 2014-10-30
Day: Thursday

Project: Renovation and Addition to Tewksbury Town Hall

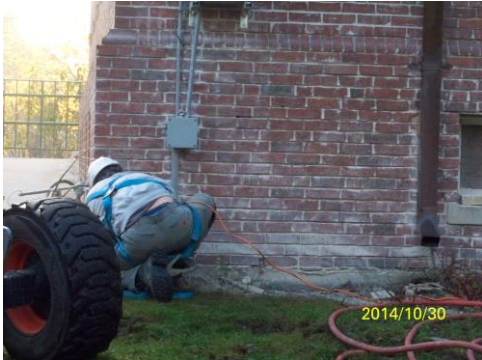
Photo showing mason cutting out joints on the west elevation of the north wing.

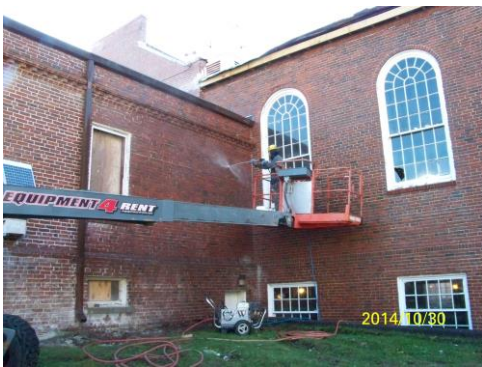
Photo showing mason power washing the west elevation of the north wing.

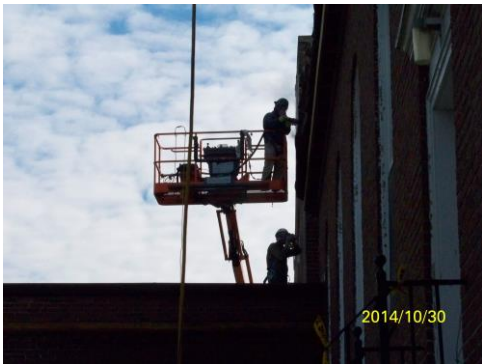
Photo showing masons working on the upper north elevation wall.

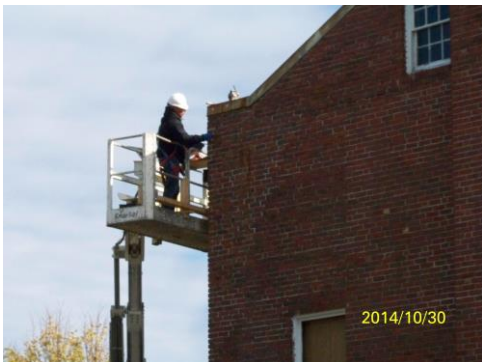
Photo showing mason working on the north end of the parapet on the west elevation.

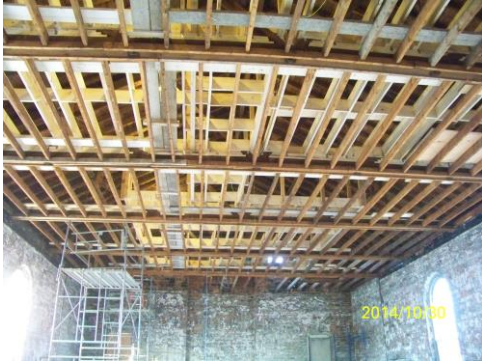
Photo showing the attic framing being installed.
This is looking west.

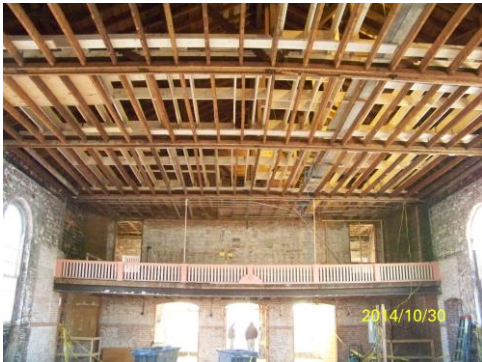
Photo showing attic framework being installed.
This is looking east.

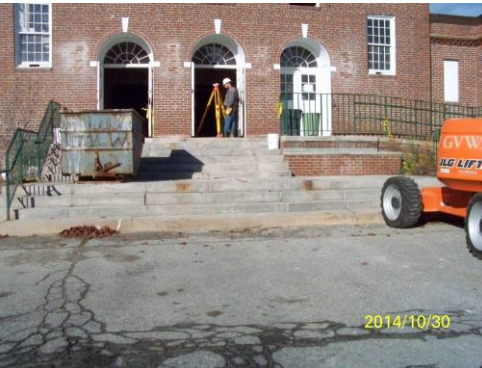
Photo showing the handrails removed and the
surveyor.

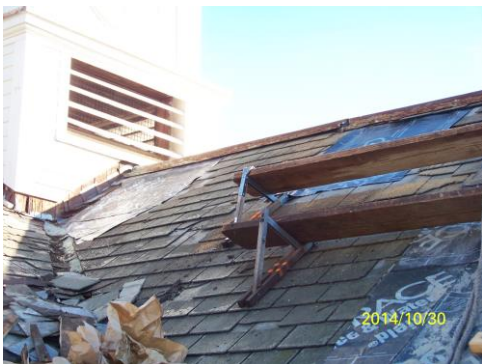
Photo showing the roof penetrations removed.

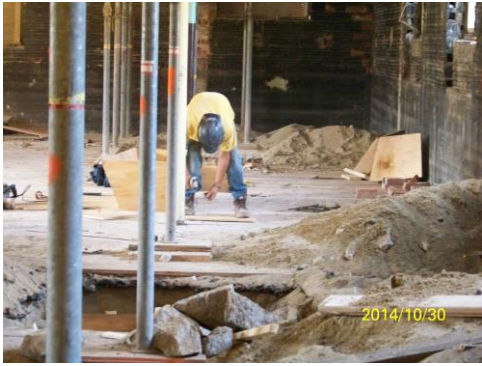
Photo showing a tradesman building the footing formwork.

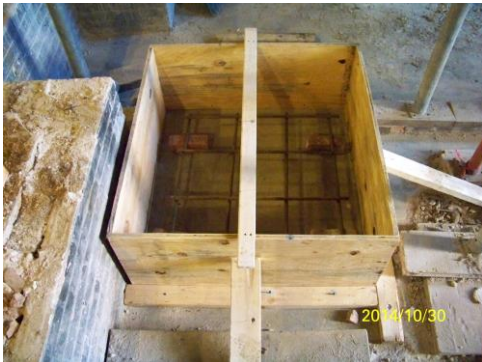
Photo showing the formwork for a new footing located in the mechanical room.

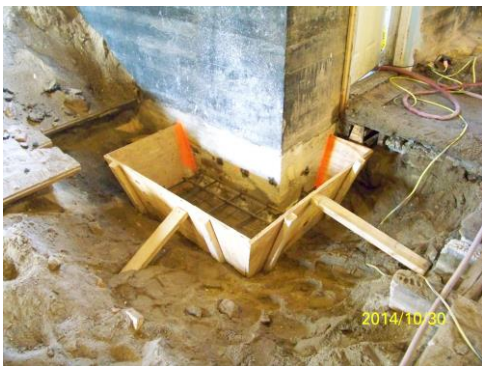
Photo showing the rebar installed at a footing location.

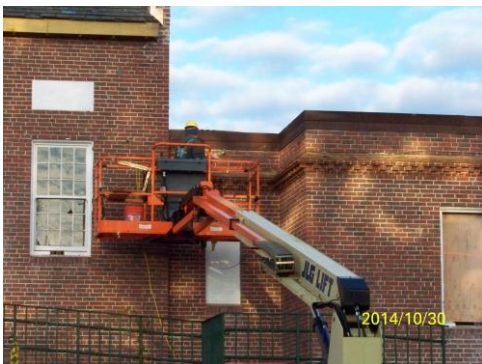
Photo showing the cable conduit being removed from the east elevation.
